COMPRESSION TESTS OF SIX CURVED PAPER-BASE PLASTIC

PANELS WITH OUTWARD-ACTING NORMAL PRESSURE

MEMORANDUM REPORT

Bureau of Aeronautics, Navy Department

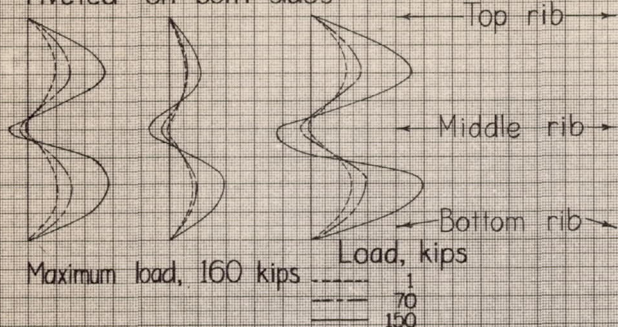
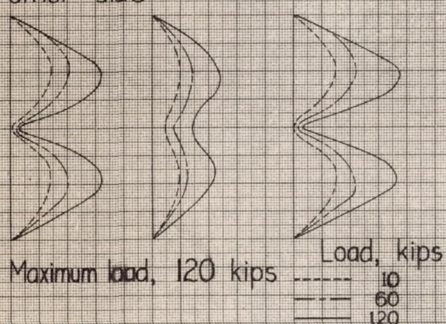
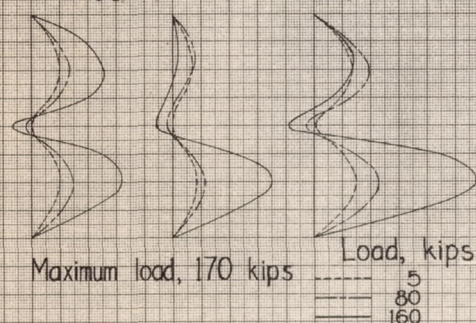
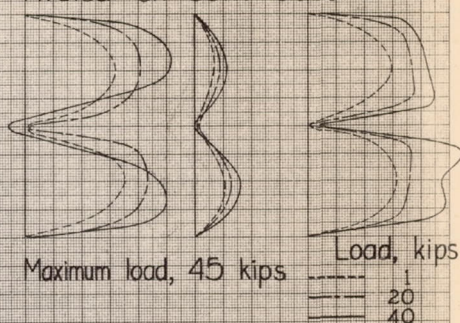
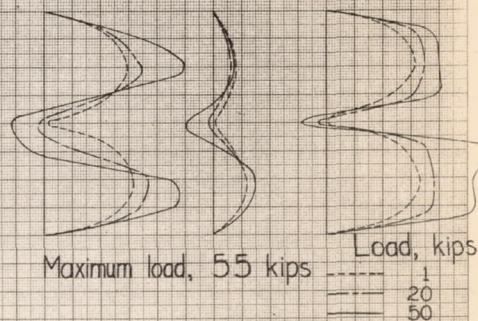
Figure 5.-Lateral-deflection plots for test panels.

The quilting effect is evident from the lateral-deflection plots of figure 5. These plots also show clearly the effect of the clip angle between the rib and stiffener in restraining the lateral movement of the stiffener where it crosses the rib (compare panel no. 2 with panels no. 1 and 3).

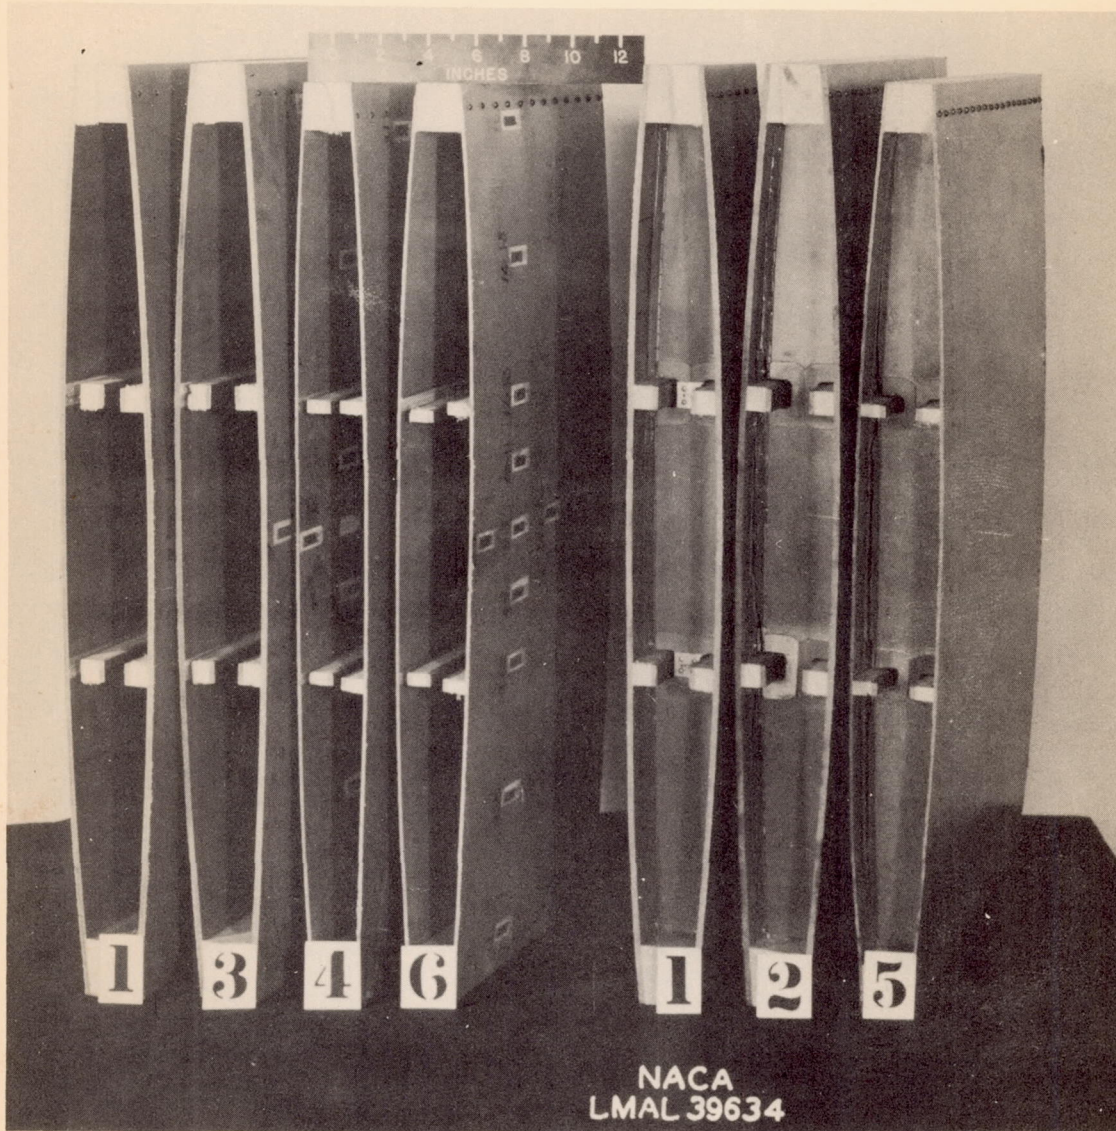
In every test failure occurred by separation of the skin, either from the rib or from the stiffeners. These separations are shown in figure 6, and the loads and corresponding average stresses at which they occurred are listed in table 2. Because the failure was a separation rather than a failure of the material, the average stresses listed in table 2 are much lower than the maximum compressive stresses for any of the materials comprising the panels. For example, panel no. 3, which

carried the highest average stress, developed about 69 percent of the maximum compressive stress for the wood spar material and about 26 percent of the maximum compressive stress for the plastic.

Separation from the rib occurred in only one specimen where the clip angles were used to attach the stiffeners to the rib (panel no. 1), and in this case separation from the stiffeners also occurred. Panels no. 2 and 5 did not have clip angles, and both these panels failed by separation of the skin from the rib, with no accompanying separation of skin and stiffeners. An examination of these two panels indicated that the failure was the result of a tearing action, which presumably began at the point where the rib is interrupted by the stiffener. In the other panels, the clip angle evidently served to tie the two skins together and thus inhibited this tearing action and delayed the separation of the skin from the rib, resulting in a higher ultimate load.

Figure 6.- Sections of test panels after failure, showing separation of skin from stiffeners and rib. (See table 2.)

The addition of clip angles to attach the stiffeners to the rib served to delay separation of the skin from the rib, and thus enabled the panels to carry a higher ultimate load.
